U.S. Department  
of Transportation

National Highway  
Traffic Safety  
Administration

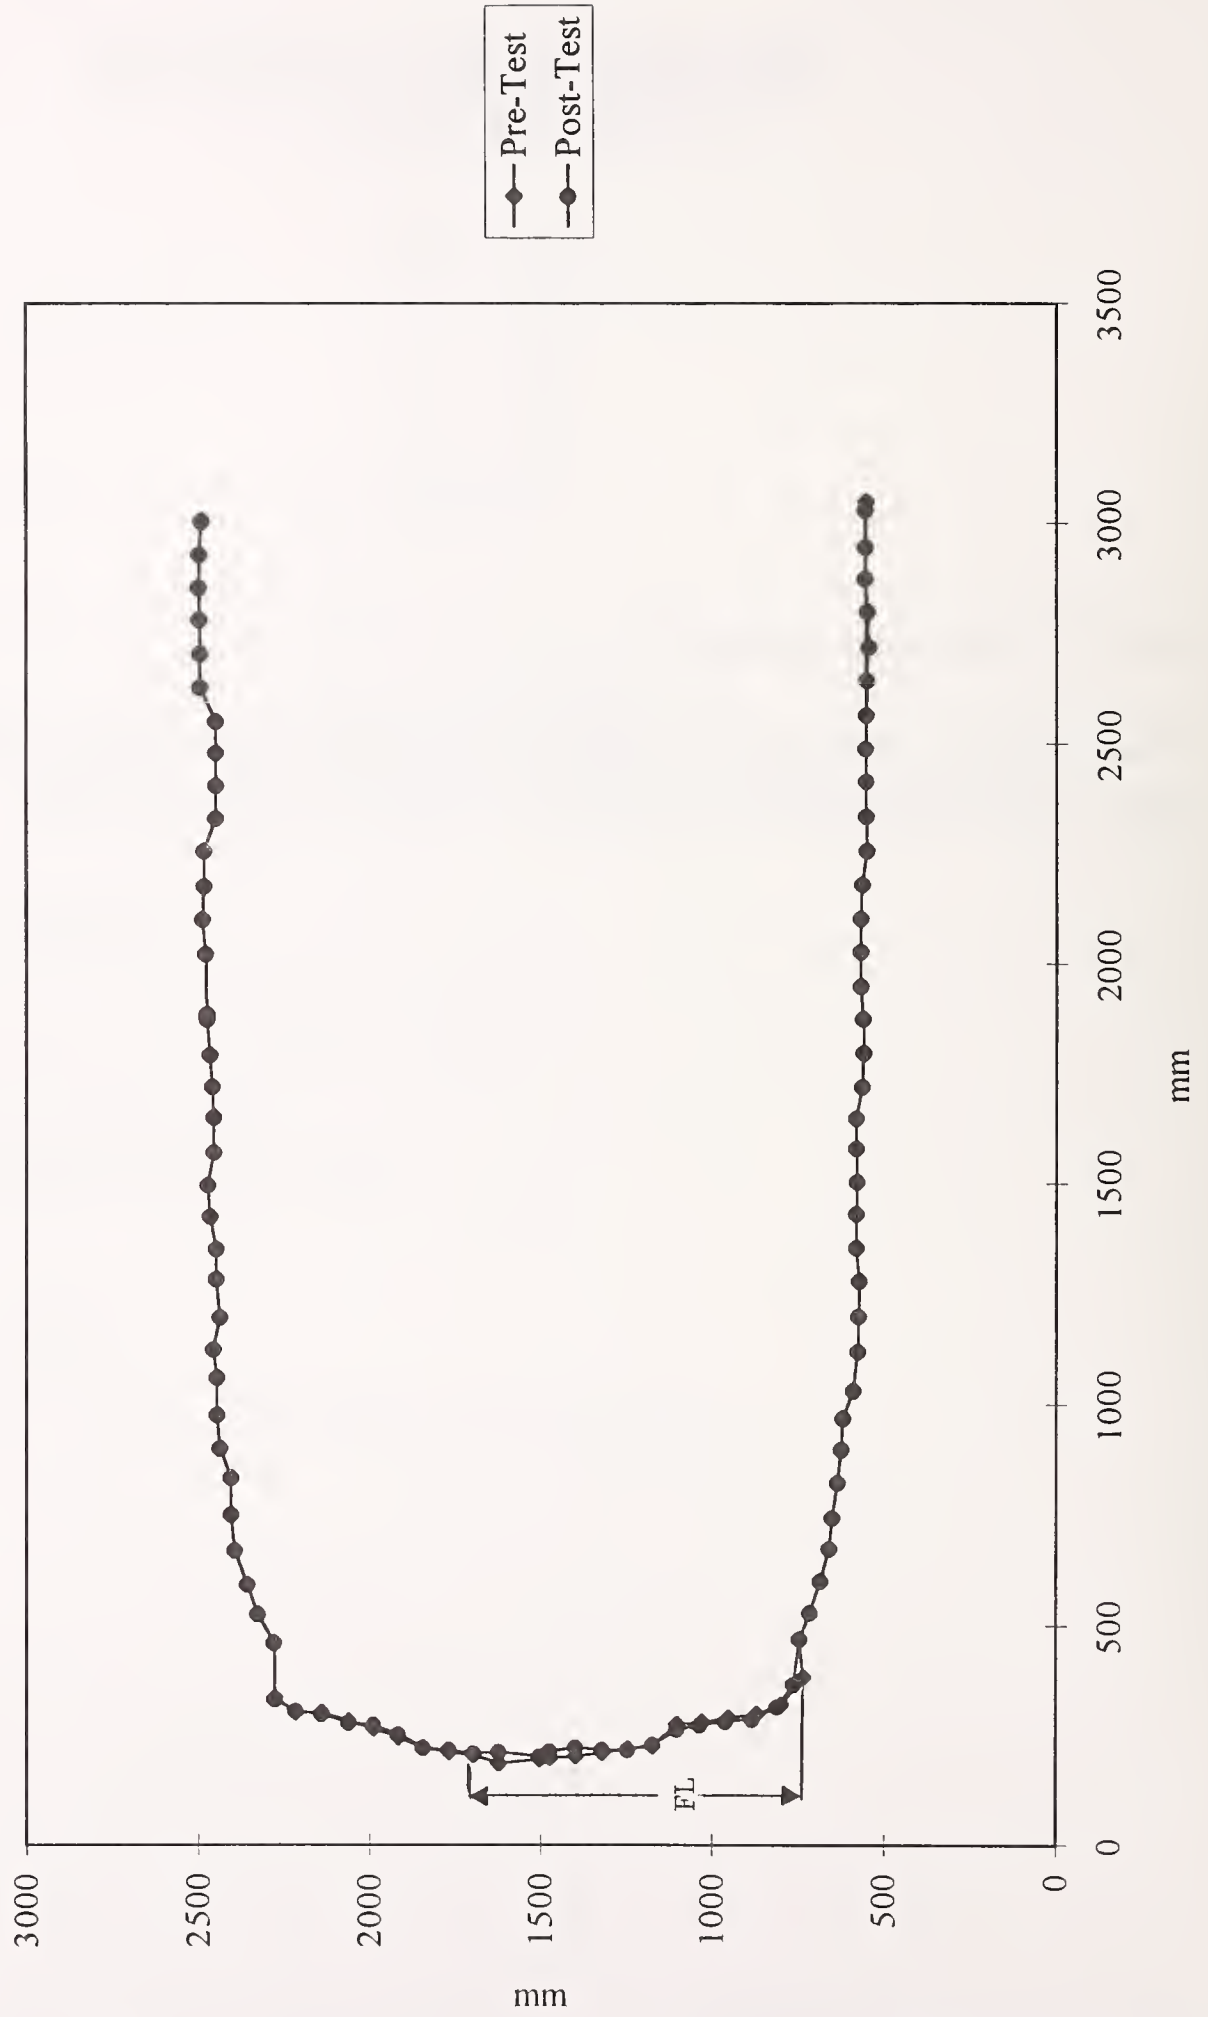
Table 5 Vehicle Measurements

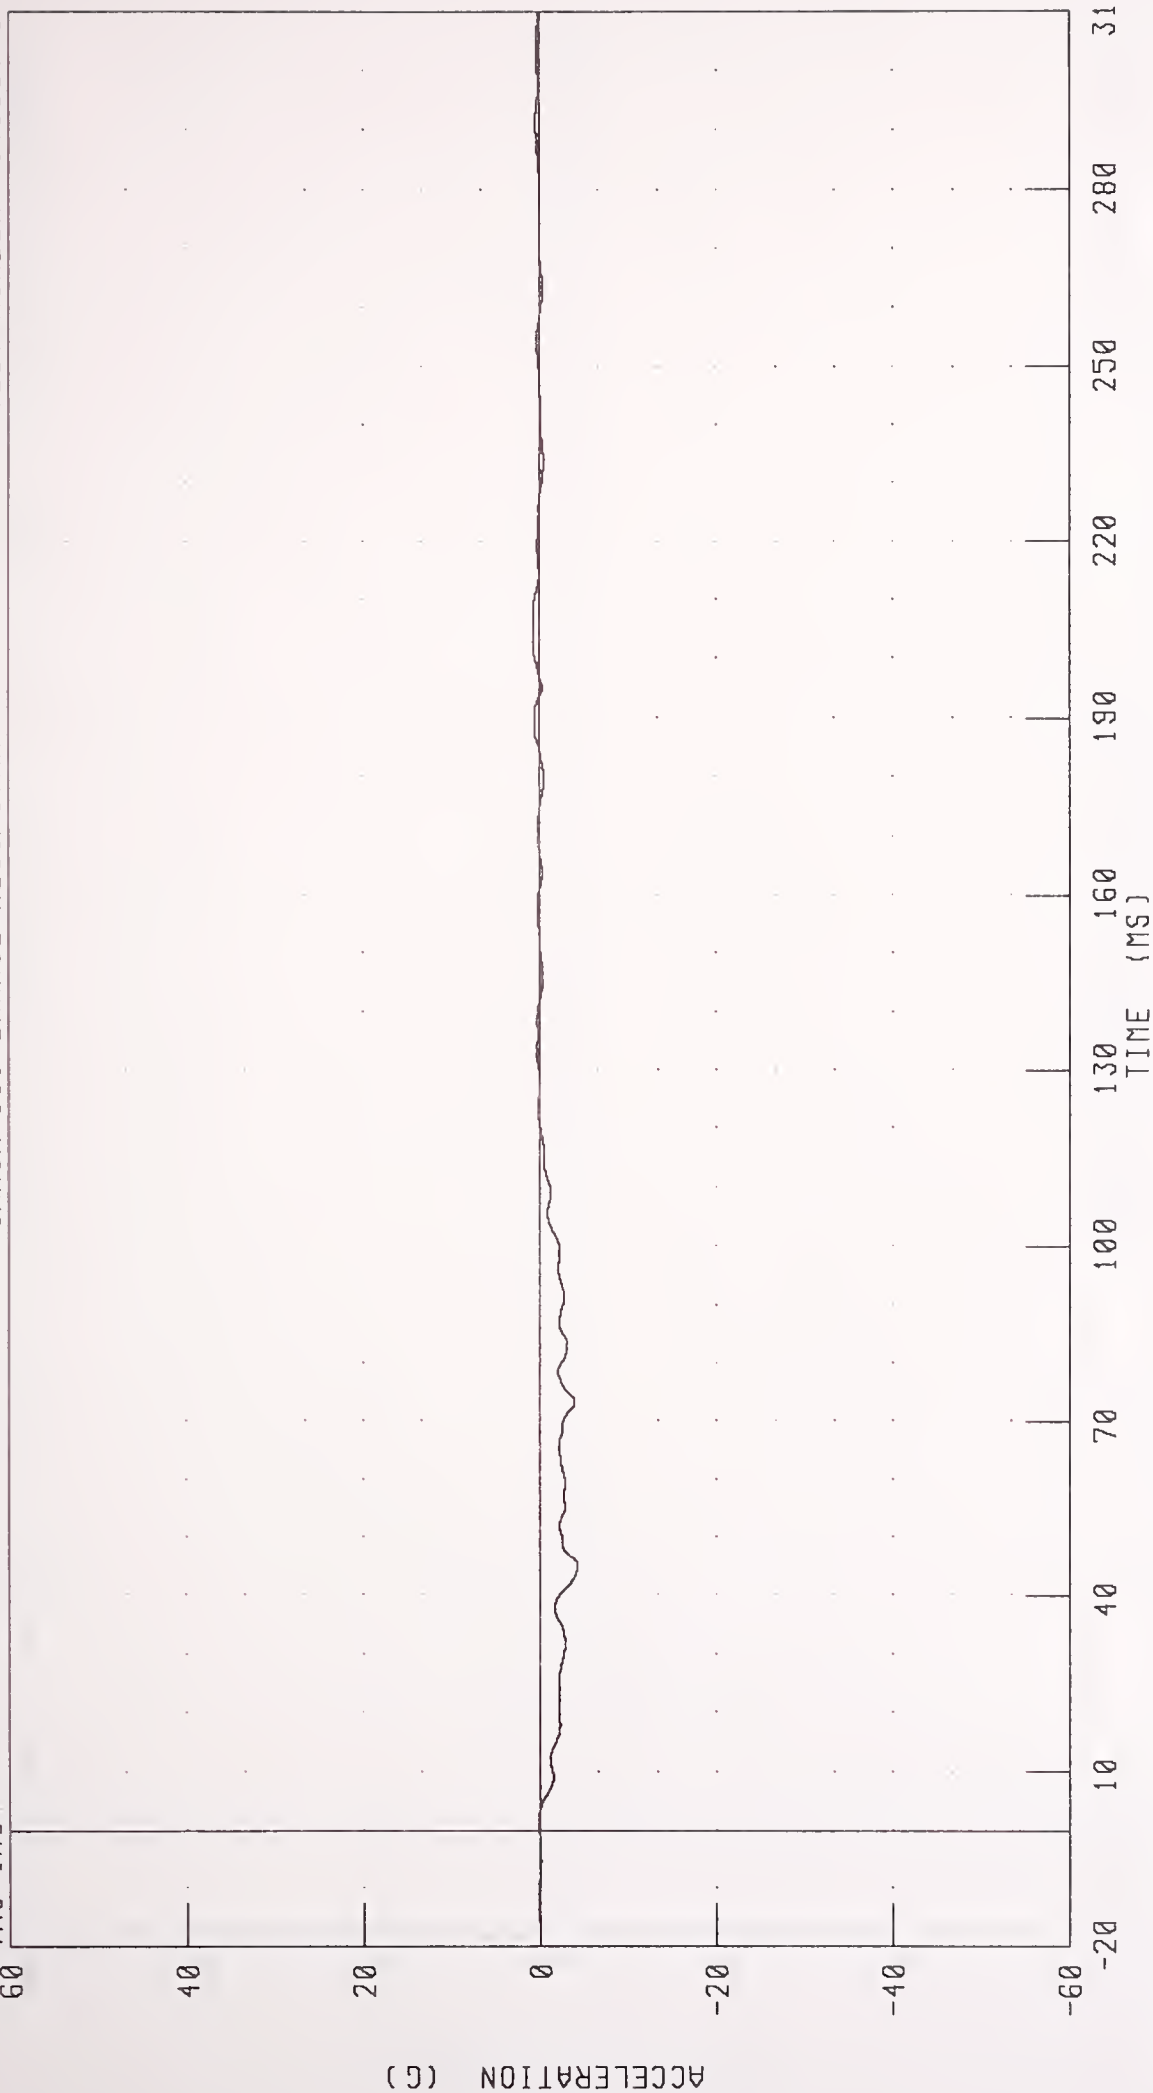
CHANNEL: VCGXG1 FILTER: CH. CLASS 60

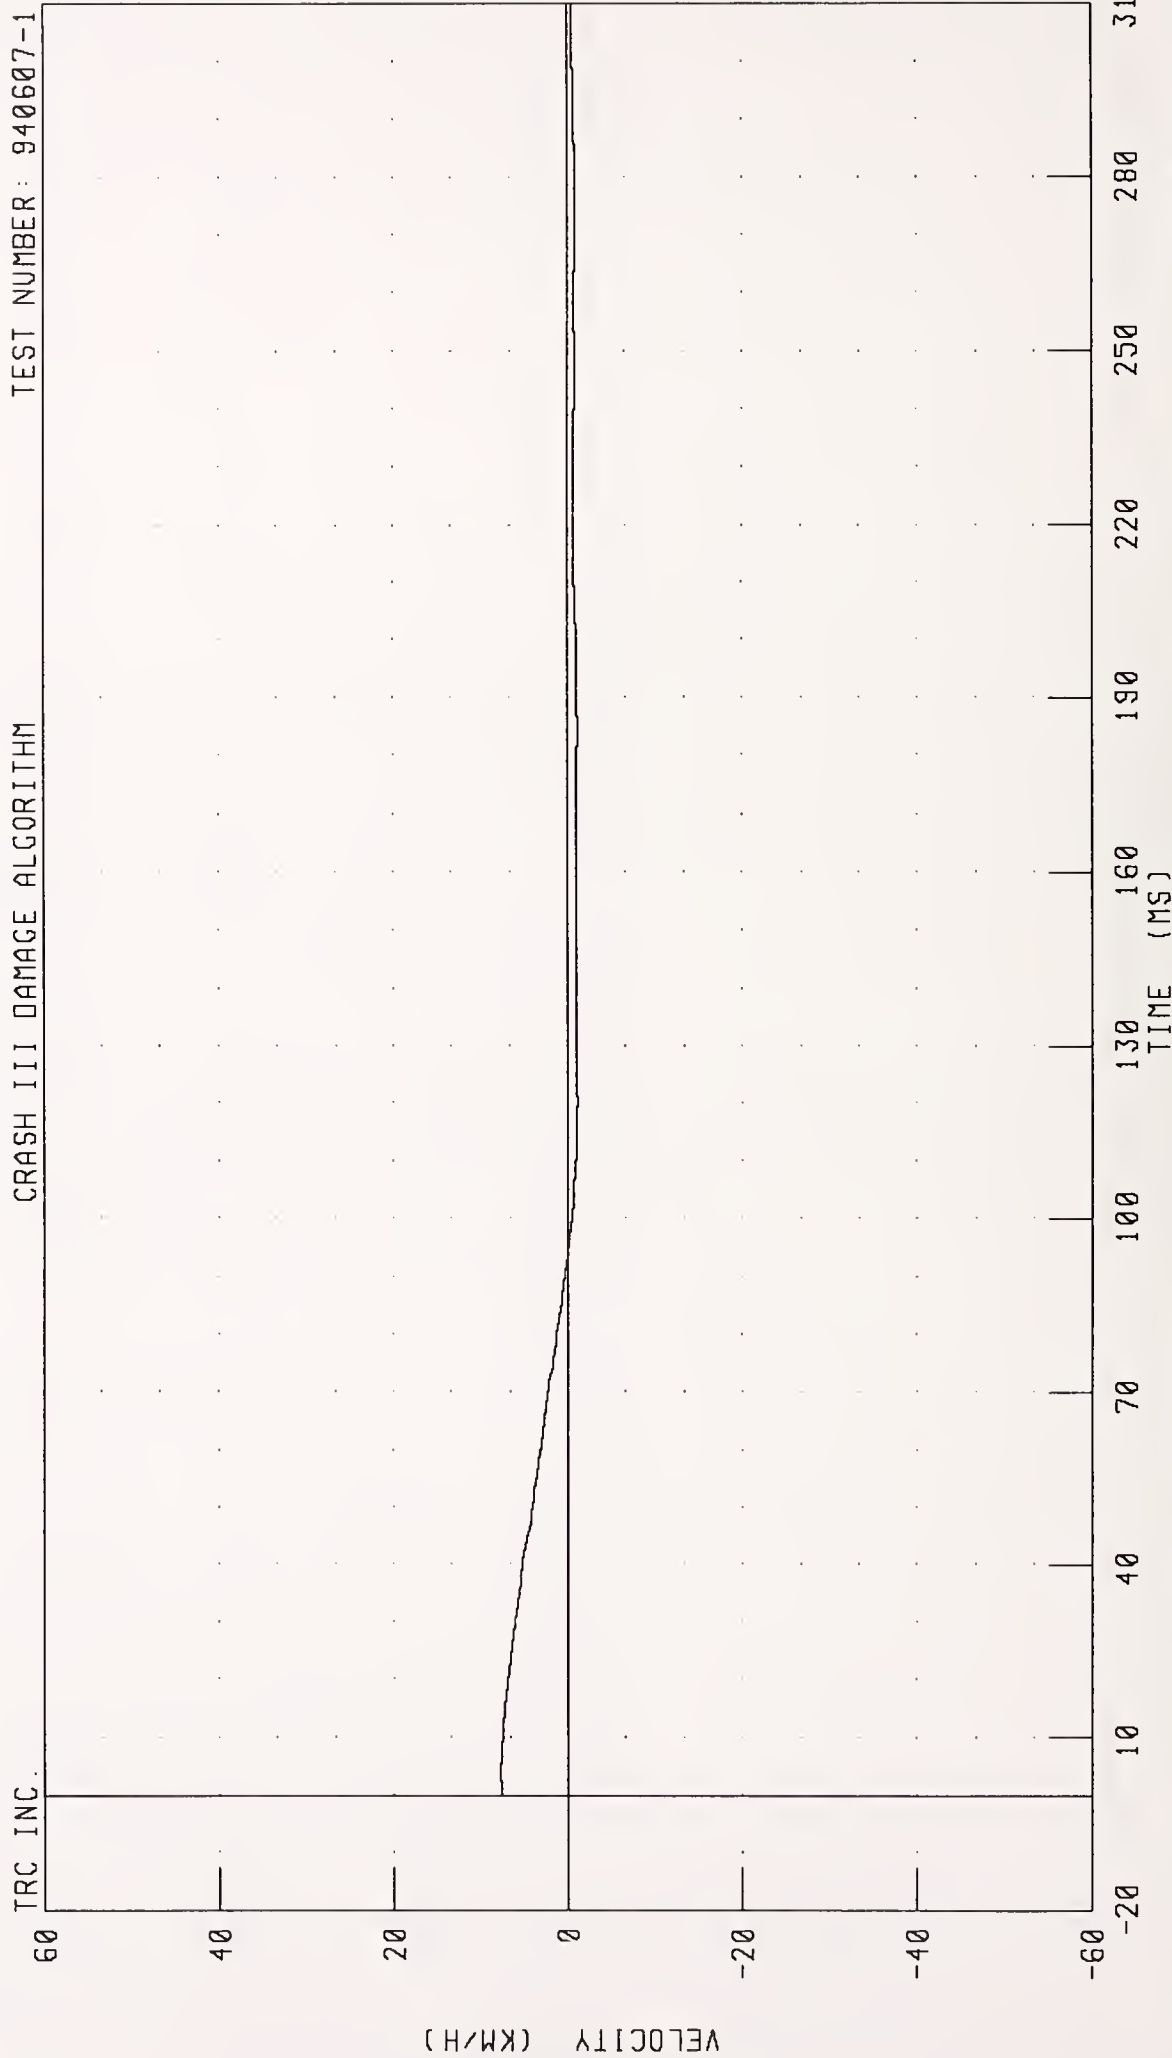
CHANNEL: VCGXV1 FILTER: CH. CLASS 180

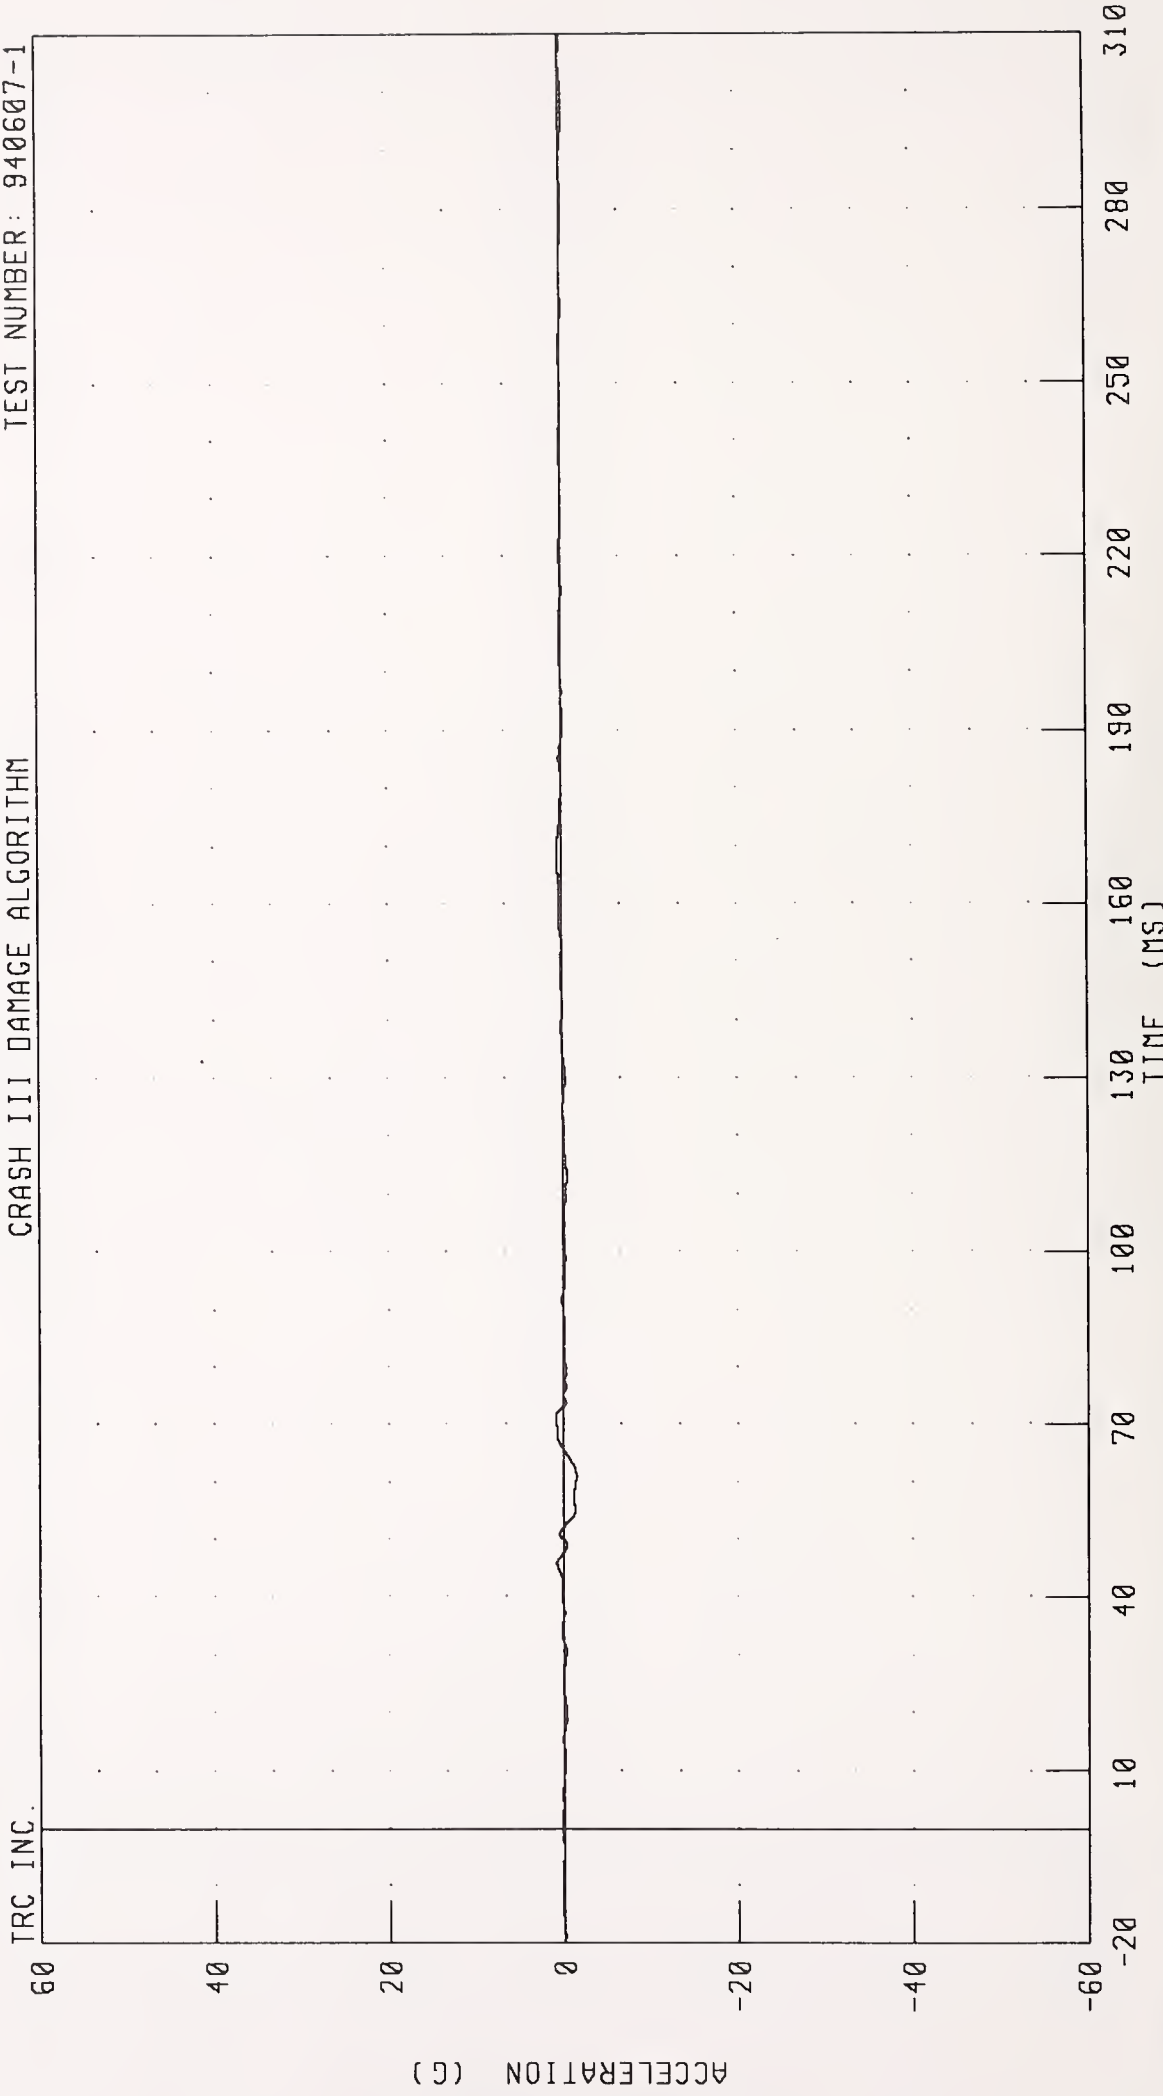
CHANNEL: VCGYG1 FILTER: CH. CLASS 60

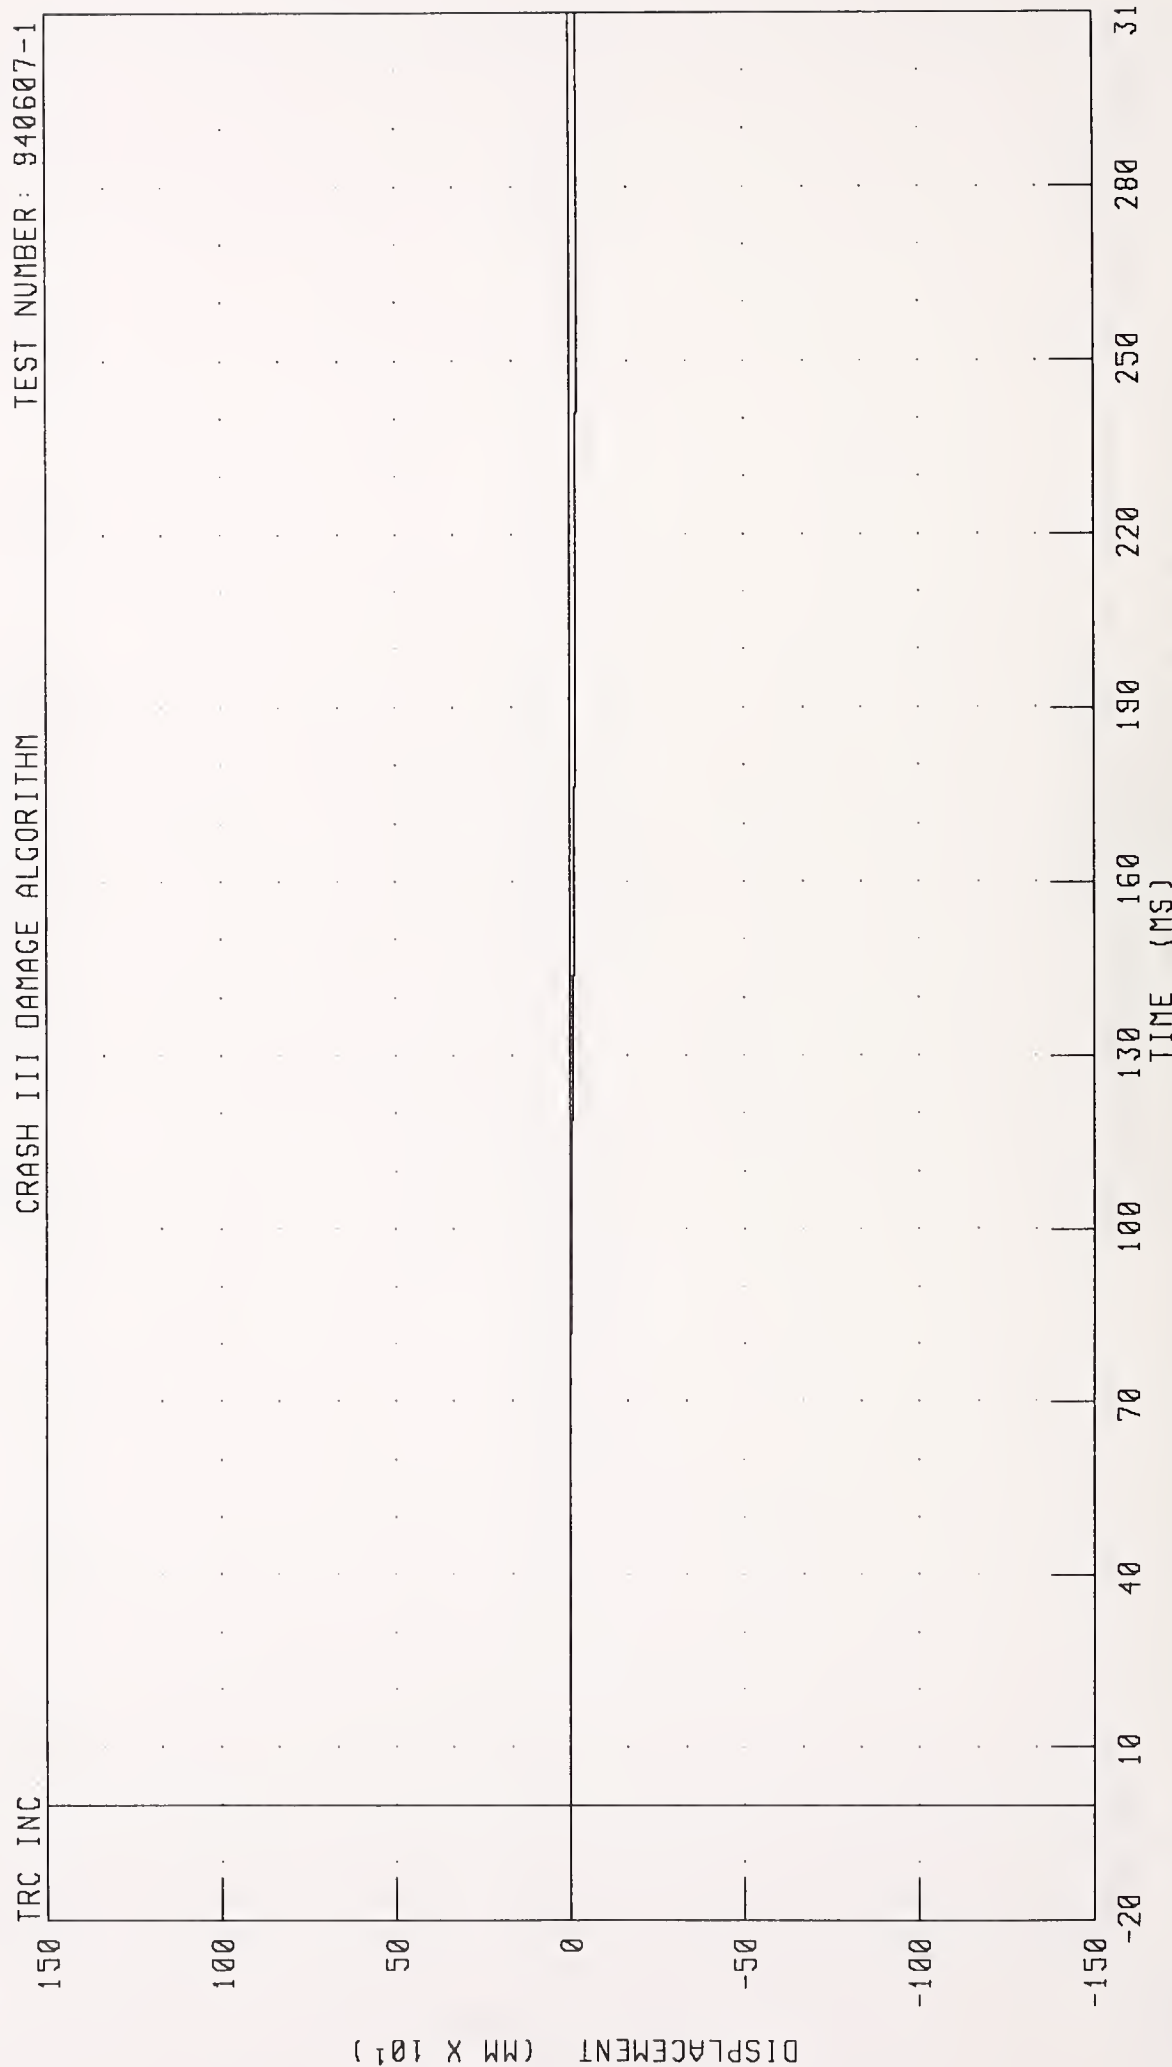
CHANNEL: VCGYD1 FILTER: CH. CLASS 180

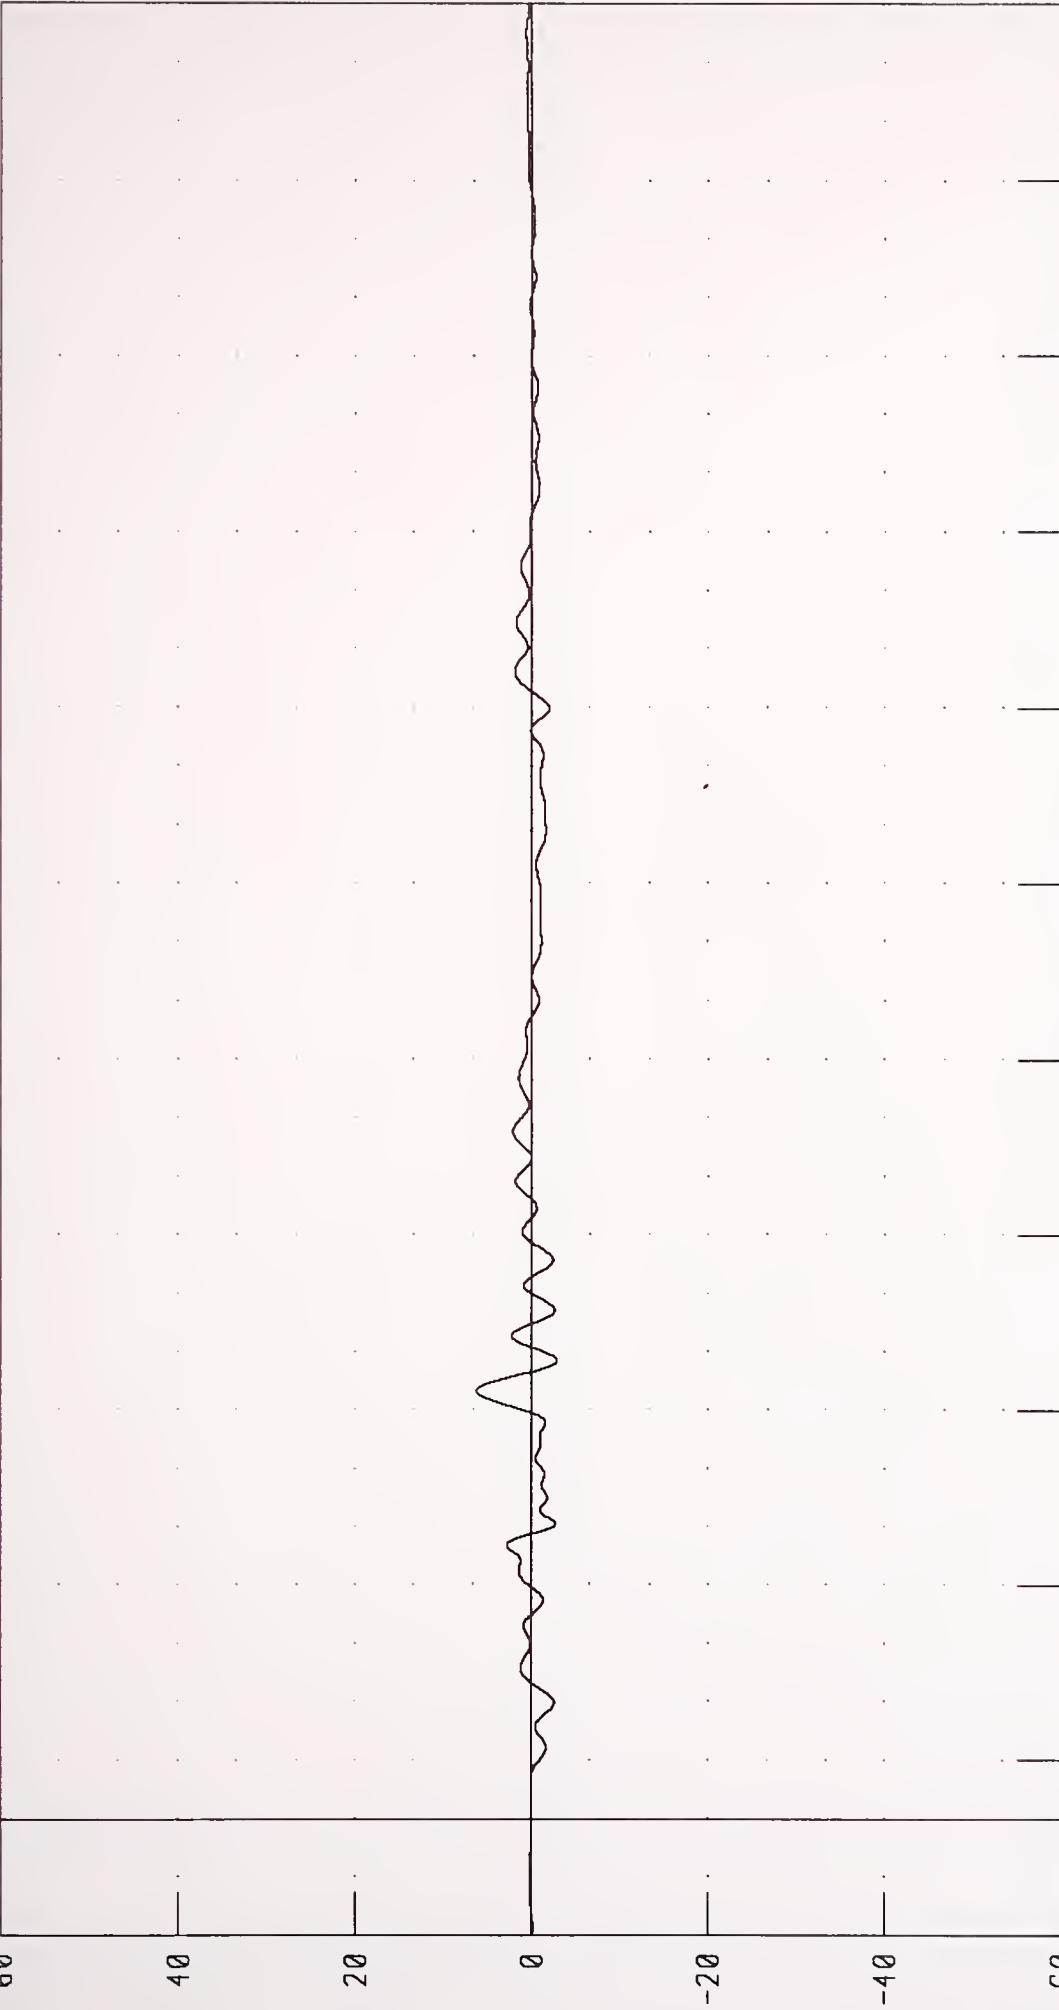
CHANNEL: VCGZG1 FILTER: CH. CLASS 60 PEAK DATA: 6.30 G @ 73.36 MS; -2.90 G @ 78.48 MS

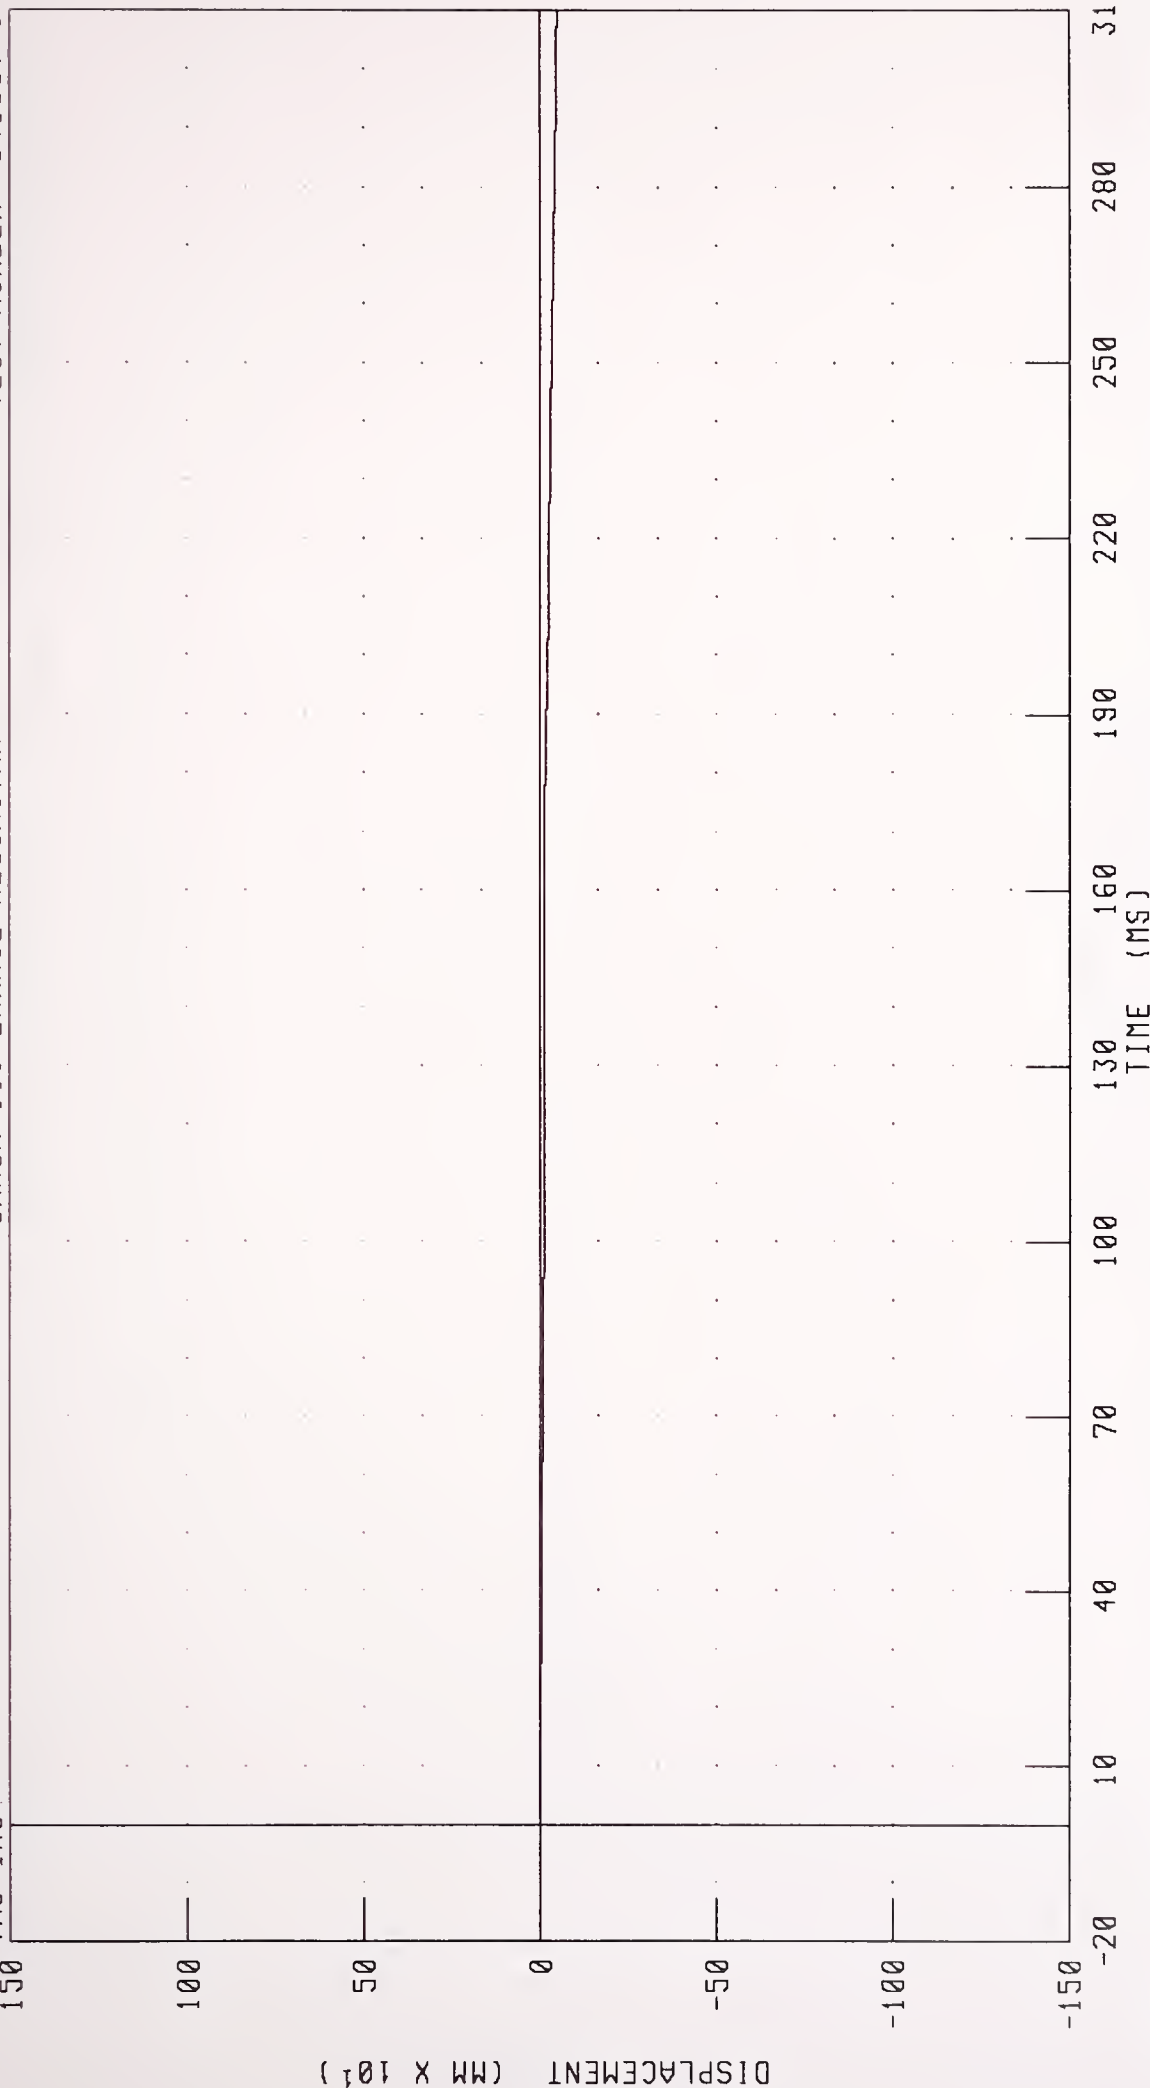
CHANNEL: VCGZD1 FILTER: CH. CLASS 180

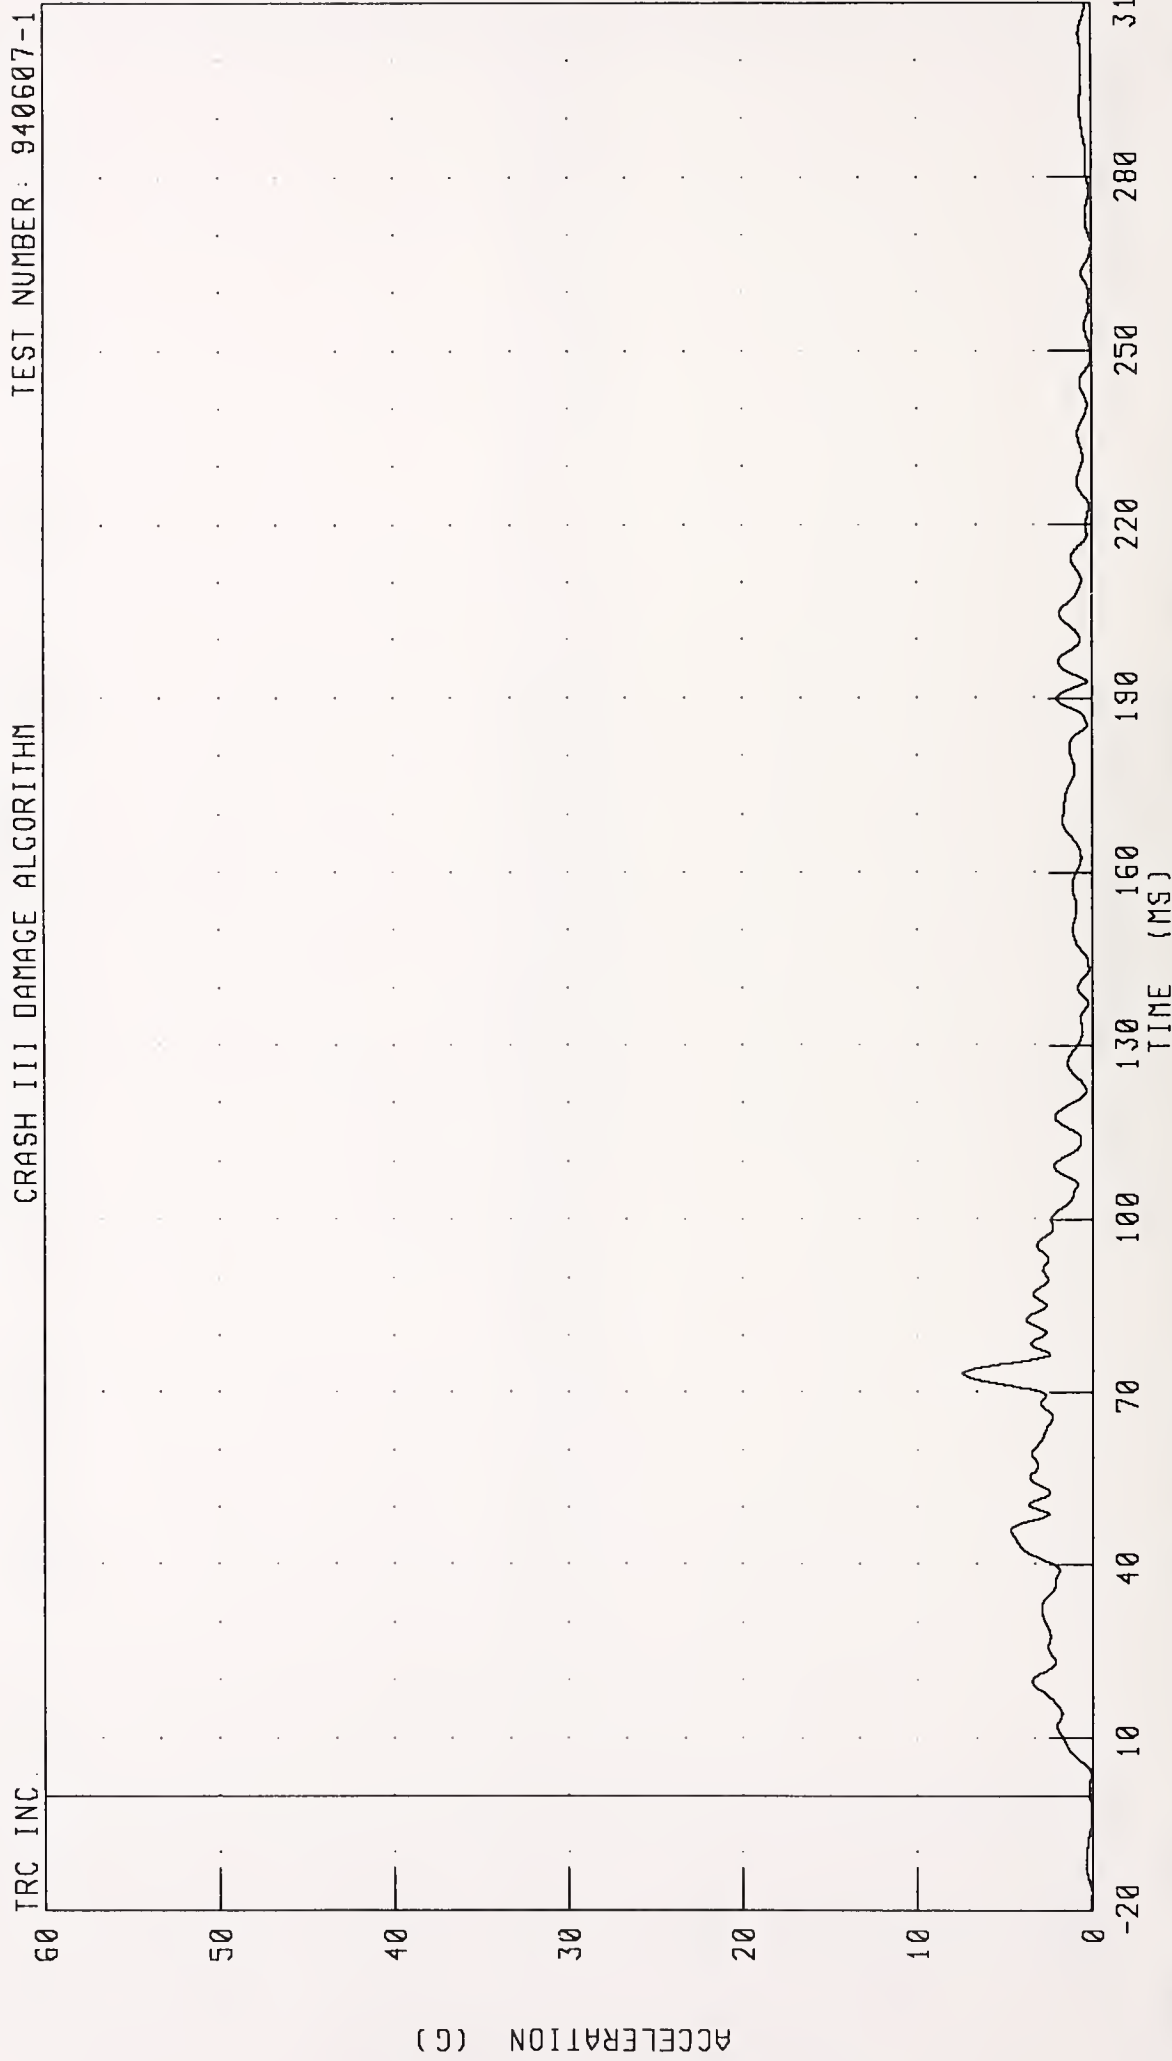
CHANNEL: VCGRG1 FILTER: CH. CLASS 60 PEAK DATA: 7.44 G @ 73.36 MS; 0.03 G @ 268.40 MS

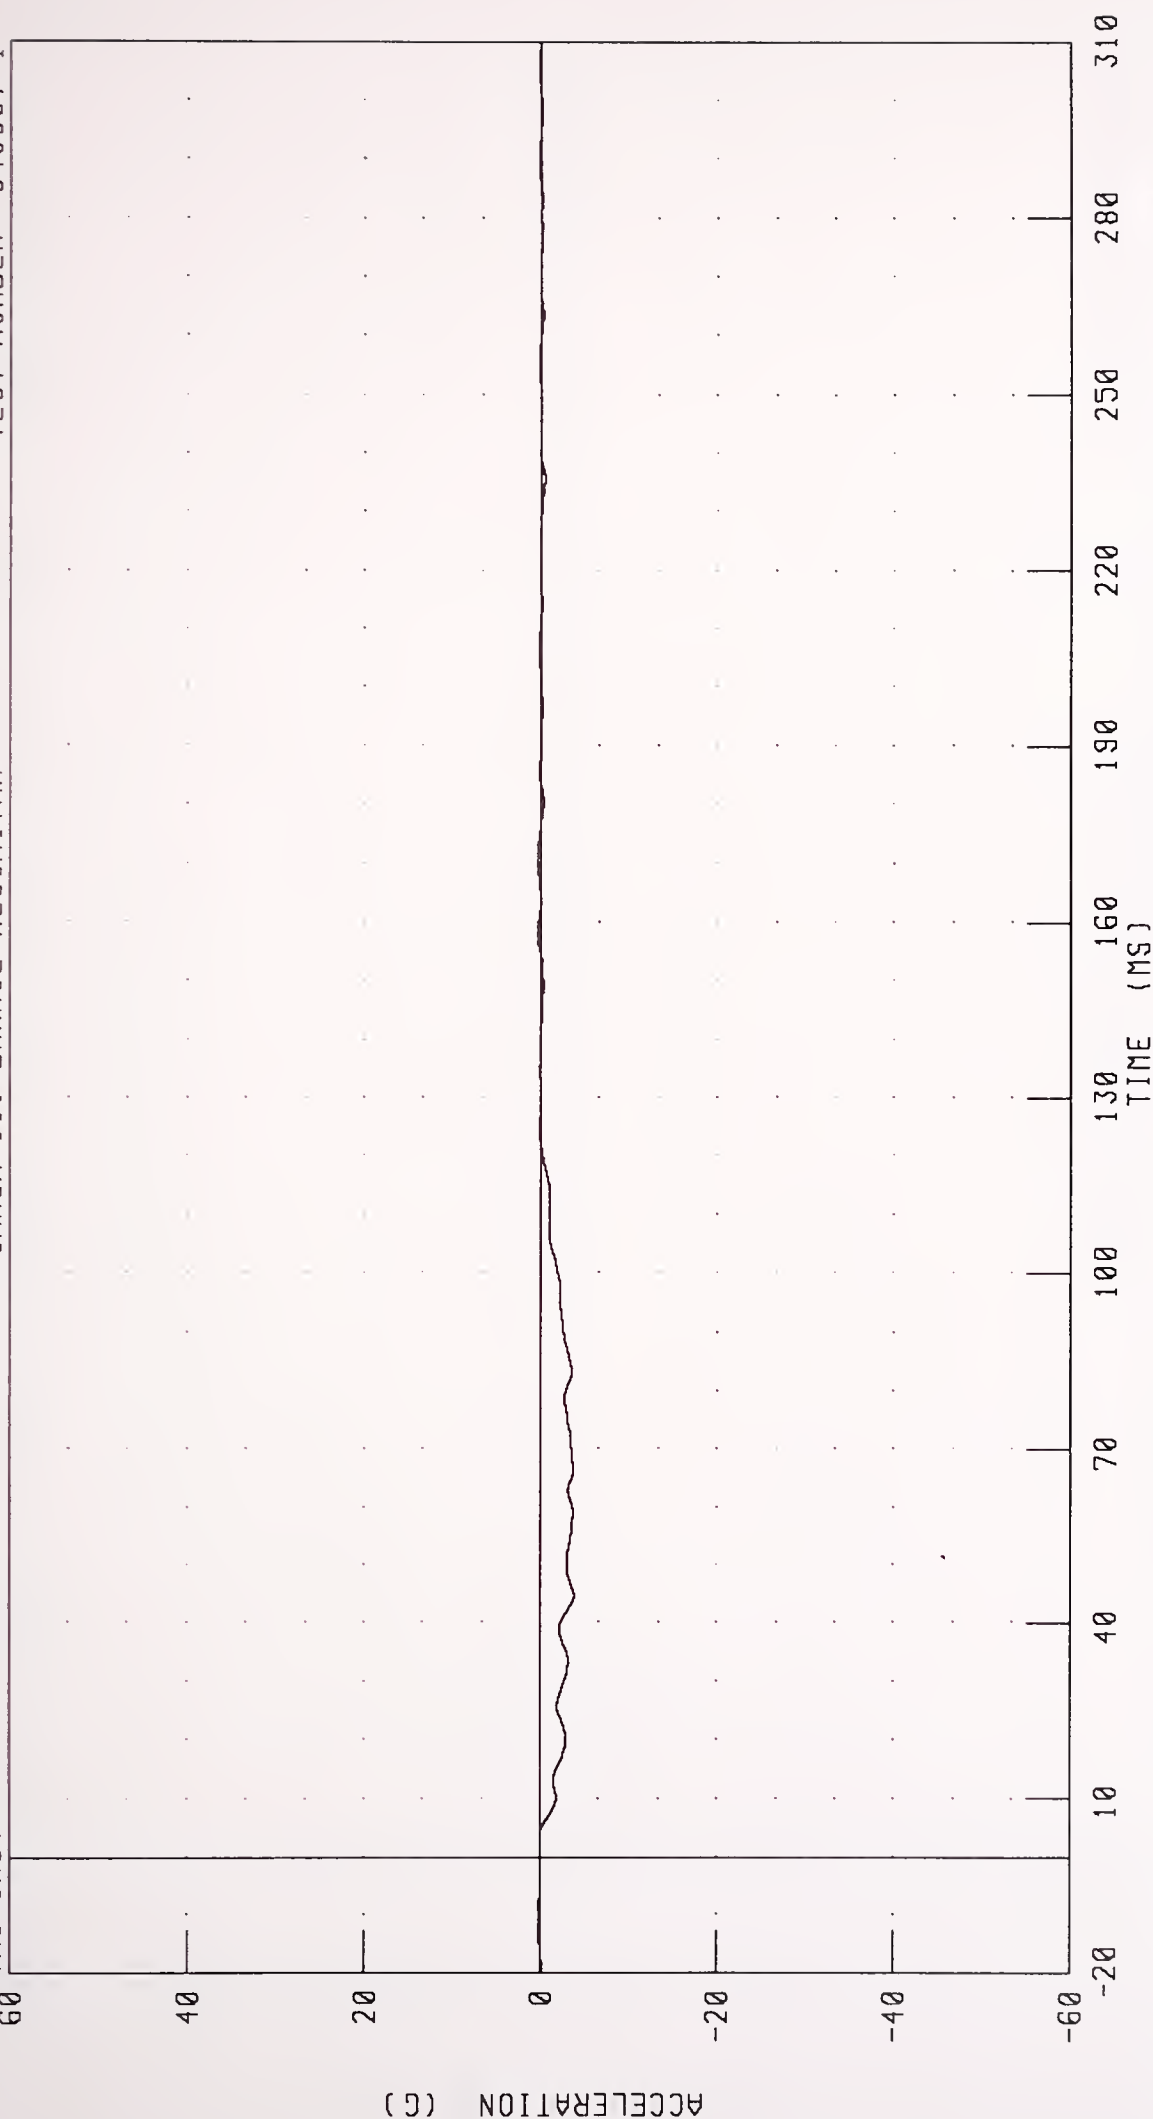
CHANNEL: LRSXG1 FILTER: CH. CLASS 60 PEAK DATA: 0.40 G @ 171.28 MS; -3.81 G @ 44.72 MS
